Notes

Phonix: a preliminary report on the 19th-century Danish steamer wrecked on the Snæfellsnes Peninsula, Iceland

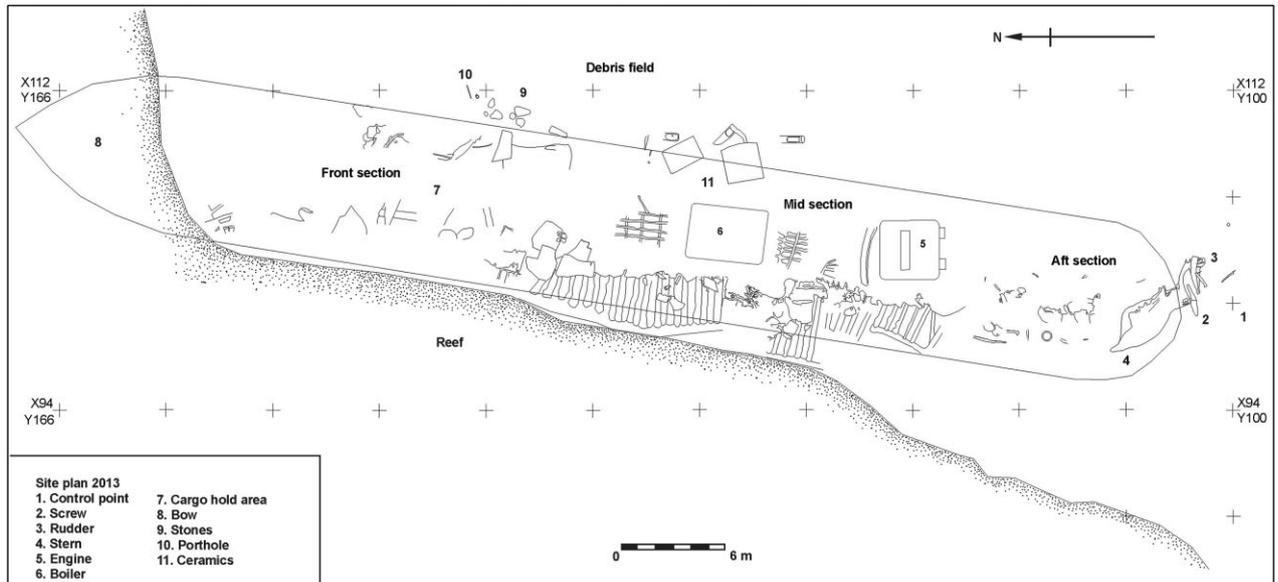
Figure 2. Site plan. (Ragnar Edvardsson)

The wreck of *Phonix* is situated on the east side of a large submerged reef. The position of the main control point installed for survey purposes (Fig. 2), is $22^{\circ}34'54.78''\text{W}, 64^{\circ}45'59.22''\text{N}$ at an absolute depth of 9 m. It is exposed to the open sea and the wreck-site is strongly affected by wave action and strong currents. The reefs may have partly sheltered the wreck and played a role in its preservation.

Finally, we took a series of vertical photographs and videotaped the wreck from the stern to the hold area. Oblique photographs were also taken from different parts of the wreck both of structural elements and finds (Fig. 4). A site map was assembled, using both the measurements and a composite image of the vertical photographs (Fig. 2).

The wreck-site covers an area 12×70 m, which can be divided into four main sections: the aft-, mid-, and fore sections of the wreck, and a field of debris on the starboard side (Fig. 2). The wreck lies on the south side of a large reef, 400×50 m, the bow at a depth of *c.* 2–3 m on the reef, and the stern at *c.* 9–12 m. The wreck is orientated 30° to 210° . The superstructure of the wreck has eroded leaving only the bottom of the hull intact, much of it buried in sandy sediments.

The survey provided the general plan (Fig. 2) of the wreck, but also enough information to reconstruct, with reference to historical sources including newspaper articles, existing paintings (Thorsøe *et al.* 1991: 131) and a drawing (Þorleifsson, 2004:), the layout of the ship (Fig. 7).

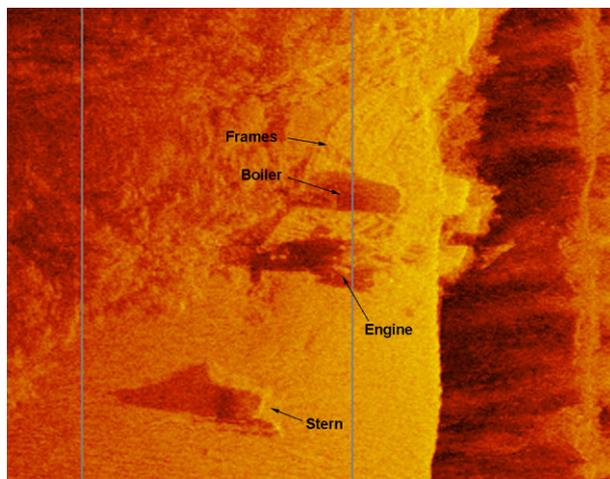
Figure 3. Sidescan sonar image of *Phönix* and the submerged reef. (Arnar Þór Egilsson)

First, a geophysical survey, using a sidescan sonar, was carried out at the wreck-site. The sidescan sonar, working on 455–800 kHz with a range of 50 m, was towed behind a boat covering the entire wreck-site (Fig. 3). Second, for underwater surveying, an iron control point was secured in a concrete block and positioned a few metres from the stern (Fig. 2). Another iron control point was set just off the bow of the wreck, but it proved to be unstable between seasons because of currents and shifting sand and had to be repositioned every season. A primary baseline was laid out between the control points, running in a NE/SW direction, following the alignment of the wreck. A buoy was

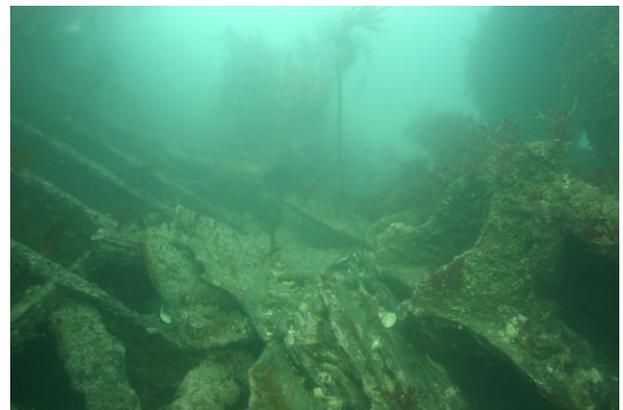
Figure 4. Port side of the wreck. The boiler is in the background. (Arnar Þór Egilsson)

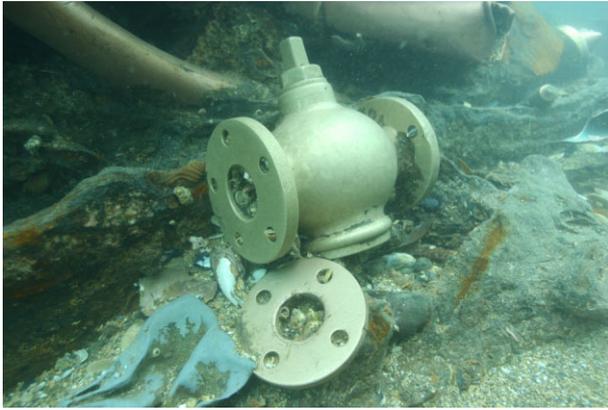
Figure 5. A valve and other engine parts close to the engine. (Arnar Þór Egilsson)

The mid section has split open and is tilted at a 20° angle towards starboard, with the port side resting against the reef. On the portside 20 frames were visible and several of the iron hull plates were still in their original position. Most of the engine (2-cylinder single stage expansion engine) lay close to its original position, but unidentified large engine parts were also scattered on its west side. The boiler (SB Scotch 3(f) GS56 HS2000 single-ended boiler) had broken loose and lay a few metres north of the engine. Two large unidentified cylindrical objects were on the west side of the boiler. Around the boiler and engine there were different engine parts, pipes, wheels, valves, handles and other unidentified parts of the engine (Fig. 5). These were all made of iron, copper or brass. Eight portholes were also recorded, some still attached to the broken hull and others lying loose in the sand, most with intact glass.

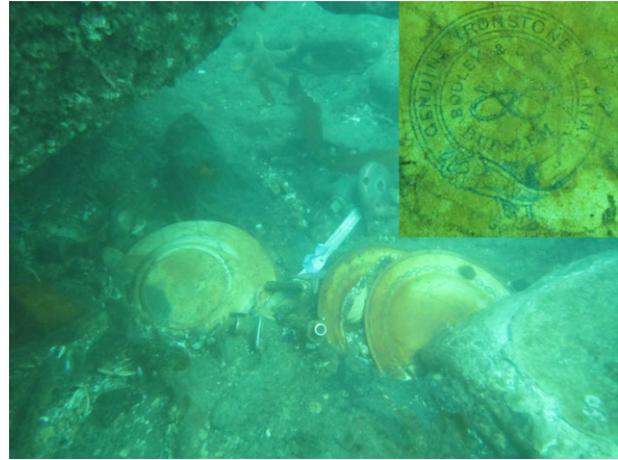
Figure 6. Ironstone ceramic dishes and bowls *in situ*; inset detail of the Bodley & Co. stamp. (Arnar Þór Egilsson)

truding from the sand and closer inspection revealed more ceramic vessels buried in the sand in the same area. The dishes were lying in a position that allowed closer inspection of shape, decoration and potters stamp, without removing them (Fig. 6).

The outer rim of the dishes was decorated with a rope pattern and the inner with a chain pattern. On one soup bowl a circular potter's stamp was clearly visible showing a 'Staffordshire knot', with the words 'Bodley & Co., Burslem' printed around the knot, and on the outer rim of the stamp the words 'Genuine Ironstone China'. Ceramic vessels of this type were first patented in 1813 by Charles Manson but once his patent expired in 1827 potters in Staffordshire and elsewhere also began producing ironstone pottery. Ironstone was mass produced and because of its sturdiness it was ideal for use at sea. The company Bodley & Co was established in 1862, but in 1883 it became Bodley & Son and operated as such until 1896. The company operated three factories: Scotia, New Bridge and Hill Top in Staffordshire (Henrywood, 1999: 35–50). The stamp provides a *terminus post quem* of 1862 for the wreck.

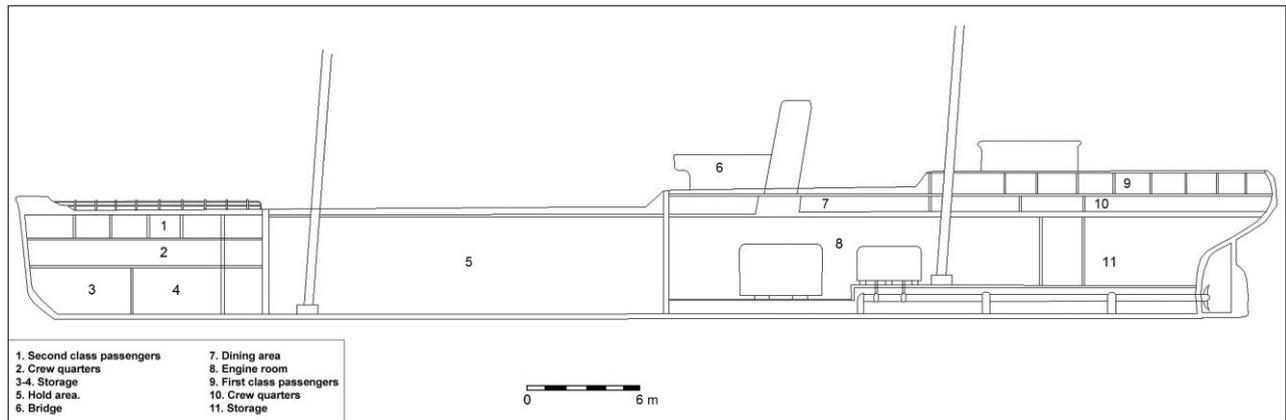
Figure 7. Reconstruction of *Phoenix* based on a painting and written sources. (Ragnar Edvardsson)
